Downtime Report

This is the Down time report for the ground fault on the 6BV3 corrector magnet on October 2, 2003.

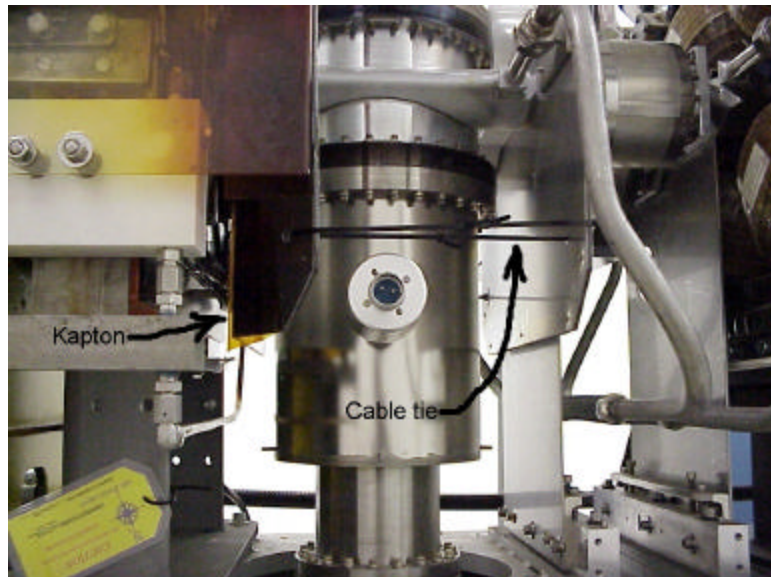
The reason for the incident was the lead shield, surrounding the wedge absorber, was touching the corrector coil conductor. The insulation wore through and created an electrical short.

The problem was solved, on 6BV3 corrector magnet, by adding a threaded rod to the assembly to pull the shield away from the conductor. Inspection of the other BV3 corrector magnets in the storage ring revealed similar problems with the shielding touching the conductor coil. This meant that all BV3 corrector magnets were at risk to the same type of problem as on 6BV3 corrector magnet. To address this, Kapton tape was inserted between the lead shielding and the corrector coil conductor to electrically insulate from shorting. A cable tie was used to pull the shield away from the conductor (see figure). This was done to the remaining corrector magnets in the storage ring. This is only a temporary fix and a permanent fix will be done at the December shutdown.

Threaded rod will be added to all shielding at the BV3 corrector magnets during the December shutdown to prevent future occurrences of this problem.
